**Flood Control Project Maintenance  
Levee Inspections  
LMA District Cover Sheet  
Spring 2012 Levee Inspection Results**

**Reclamation District No. 0501 Ryer Island**

**Spring 2012 Levee Inspection Results**

Waterway	Bank	Unit Miles
Unit No. 01 Steamboat Slough	Right	6.76

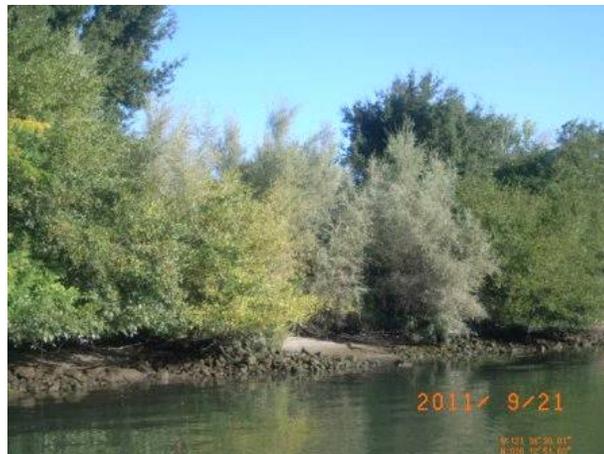
Levee Mile Report Line	32
Start Levee Mile	2.80
End Levee Mile	2.80
Location	Water Side
Category	Supplemental
Item	USACE Erosion Survey
USACE 2011 Photo #1	
phillips_s_20120306_155.jpg

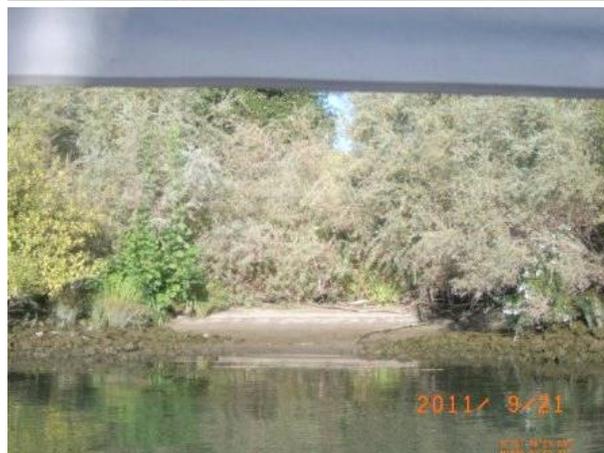
Levee Mile Report Line	32
Start Levee Mile	2.80
End Levee Mile	2.80
Location	Water Side
Category	Supplemental
Item	USACE Erosion Survey
USACE 2011 Photo #2	
phillips_s_20120306_156.jpg

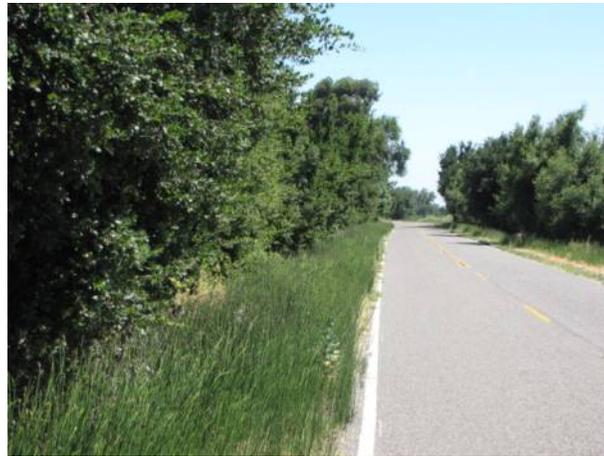
Levee Mile Report Line	38
Start Levee Mile	3.34
End Levee Mile	3.36
Location	Land Side
Category	Earthen Levee
Item	Trim / Thin Trees

Wild growth of trees on the landward shoulder and slope on levee. Standing at levee mile 3.34 looking downstream to levee mile 3.36.

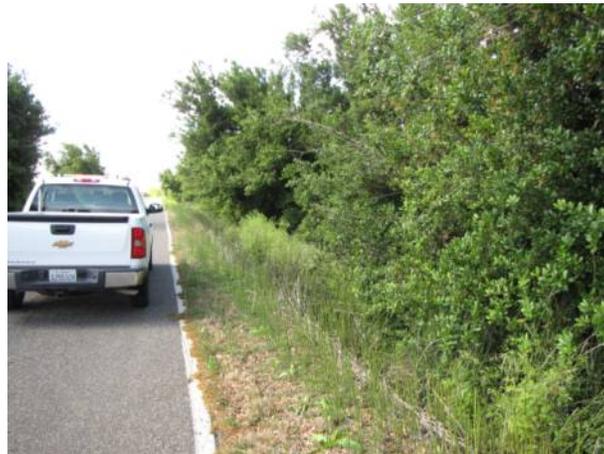
Levee Mile Report Line	38
Start Levee Mile	3.34
End Levee Mile	3.36
Location	Land Side
Category	Earthen Levee
Item	Trim / Thin Trees

Standing on levee mile 3.34 looking downstream towards levee mile 3.36 landward of Unit 1 RD 501 at the unsatisfactory wild growth on the levee slope. Photo taken 4-19-11

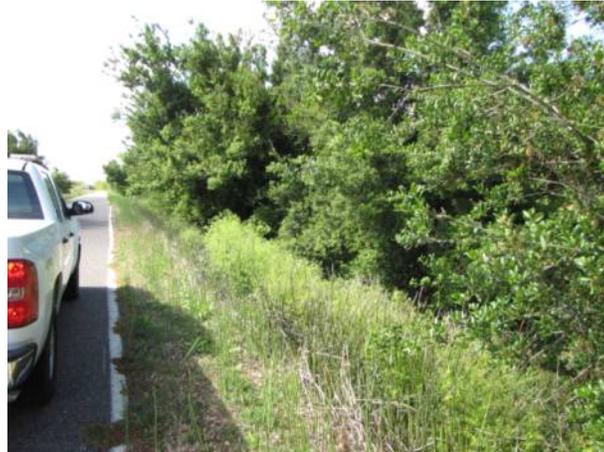
Levee Mile Report Line	38
Start Levee Mile	3.34
End Levee Mile	3.36
Location	Land Side
Category	Earthen Levee
Item	Trim / Thin Trees
<p>Another photo of the unsatisfactory growth on levee slope from levee mile 3.34 to 3.36. Photo taken 4-19-11.</p> <p>phillips_s_20120306_160.jpg</p>

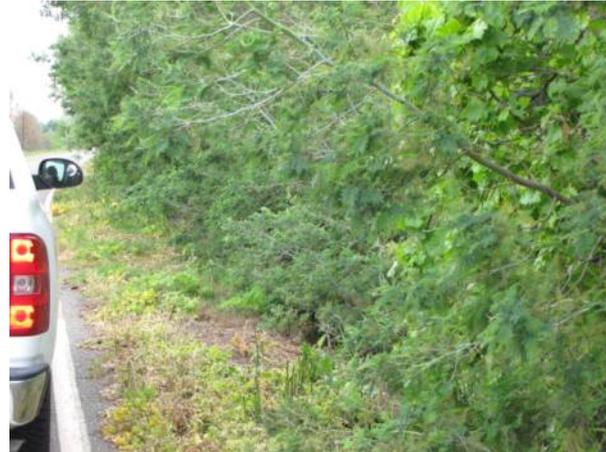
Levee Mile Report Line	48
Start Levee Mile	3.80
End Levee Mile	4.14
Location	Land Side
Category	Earthen Levee
Item	Vegetation
Looking downstream levee mile 3.80- 4.14. Photo taken 4-25-2012.	
phillips_s_20120524_446.jpg

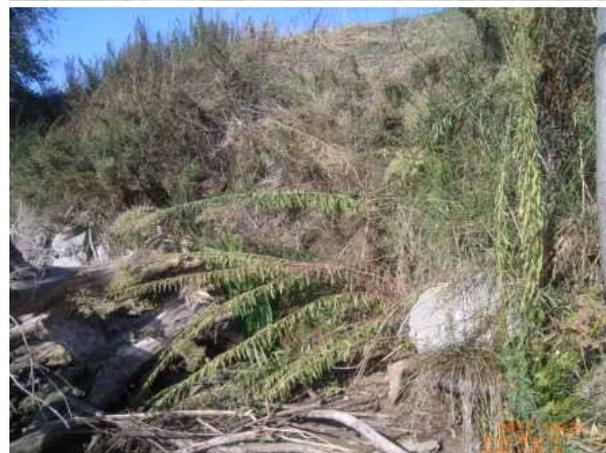
LMR No.	Levee Mile		Category	Item	* Location	** Rating	Action/Comment	GPS Latitude/Longitude		Issue No. Photo
	Start	End						Start	End	
56	5.73	5.75	Supplemental	USACE Erosion Survey	WS	M Ma	Inspector Comments: 2008 - Overstepped levee section with multiple small pockets of erosion 10 - 20 ft wide. 2011: No observed changes. [2011 Site ID: STM_15-7_R]	38.190001 ° -121.643160 °	38.189311 ° -121.643917 °	44 Y
DWR ID: DWR_RD0501_01_s_2012_44										
57	5.75	5.79	Earthen Levee	Vegetation	WS	M Ma	V2 : Remove the wild growth other than native grasses from the levee slopes.	38.190590 ° -121.642468 °	38.190246 ° -121.643164 °	24
DWR ID: DWR_RD0501_01_s_2012_24										
58	5.92	6.21	Earthen Levee	Vegetation	LS	M Ma	V2 : Remove the wild growth other than native grasses from the levee slopes.	38.188929 ° -121.644645 °	38.185941 ° -121.648359 °	20
DWR ID: DWR_RD0501_01_s_2012_20										
59	5.93	5.93	Earthen Levee	Encroachments	WS	U Ma	PI : Pipe Inspector Comments: The land owner has started installing a new pipe and pump at this location without a permit. He has been given instruction to stop all work until a permit is issued. The District has instructed him to get permit.	38.193329 ° -121.636872 °	38.193329 ° -121.636872 °	33 Y

Levee Mile Report Line	56
Start Levee Mile	5.73
End Levee Mile	5.75
Location	Water Side
Category	Supplemental
Item	USACE Erosion Survey
USACE 2011 Photo #1	
phillips_s_20120306_161.jpg

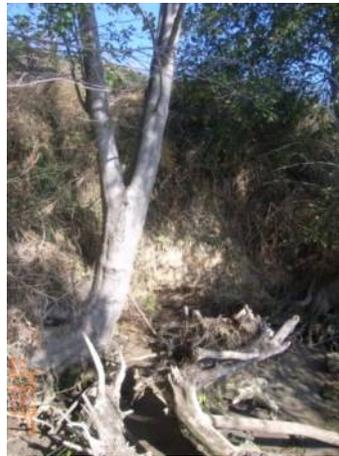
USACE 2011 Photo #3

Levee Mile Report Line	56
Start Levee Mile	5.73
End Levee Mile	5.75
Location	Water Side
Category	Supplemental
Item	USACE Erosion Survey

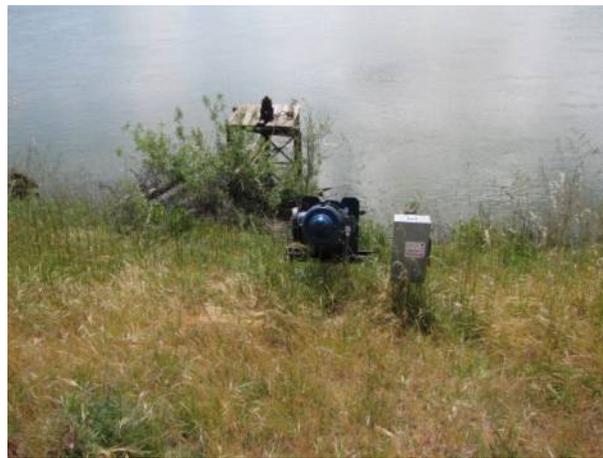
Levee Mile Report Line	59
Start Levee Mile	5.93
End Levee Mile	5.93
Location	Water Side
Category	Earthen Levee
Item	Encroachments

Photo of unauthorized pipe, pump and electrical box placed on waterward slope.

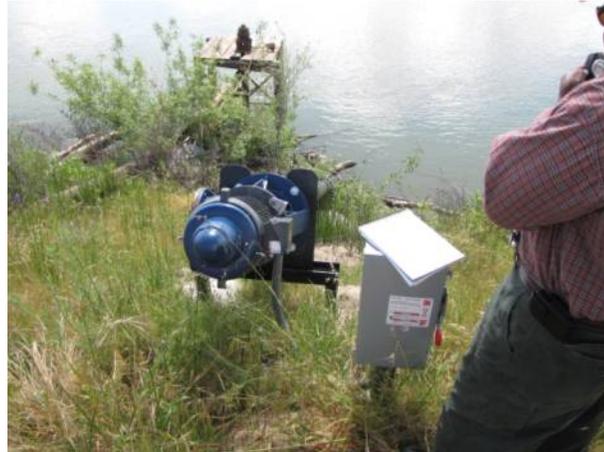
Another view of the unauthorized pipe. At levee mile 5.93. Unit 1 RD 501. Photo taken 4-19-11.

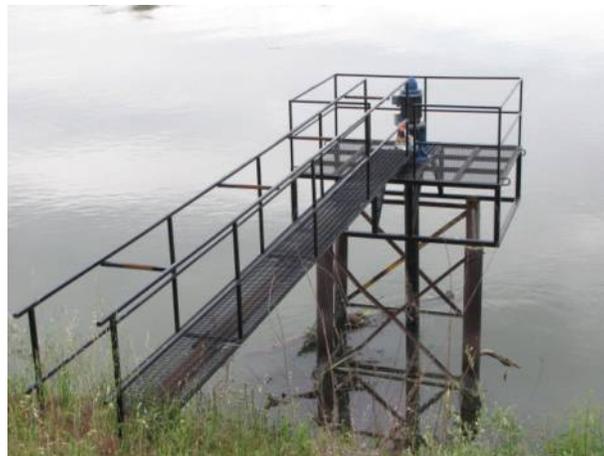
Levee Mile Report Line	59
Start Levee Mile	5.93
End Levee Mile	5.93
Location	Water Side
Category	Earthen Levee
Item	Encroachments

Photo taken of new pump structure. Photo taken 4-25-2012.

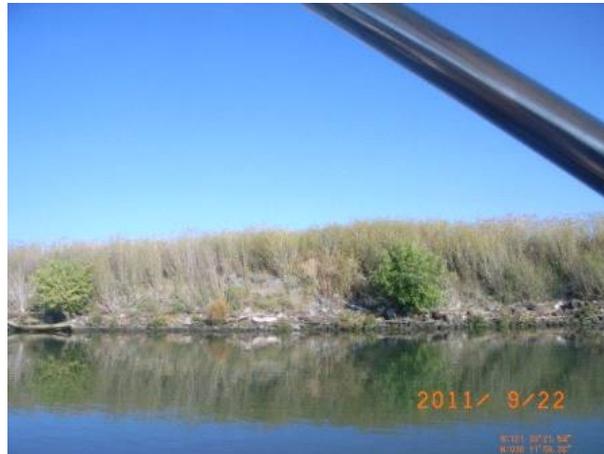
USACE 2011 Photo #1

DWR ID: DWR_RD0501_02_s_2012_11										
5	1.03	1.03	Supplemental Levee	USACE Erosion Survey	WS Ma	M	Inspector Comments: 2005 - Large vertical sections due to wave wash. New stone dumped on the bank with exposed geotextile. Cohesive toe has thin weak stratigraphic unit that is washing out. 2006 - Partially repaired, but 100 ft in the middle of the reach has exposed filter fabric and stone riprap is gone. 2010 - Site extended downstream to include new erosion pocket. 2011: No observed change. [2011 Site ID: CHS_15-9_L]	38.199128 ° -121.655881 °	38.200146 ° -121.655638 °	6 Y
DWR ID: DWR_RD0501_02_s_2012_6										
6	1.03	1.03	Earthen Levee	Erosion / Bank Caving	WS Ma	M	E1 : Note and monitor erosion site.	38.198153 ° -121.655614 °	38.198153 ° -121.655614 °	10 Y
DWR ID: DWR_RD0501_02_s_2012_10										
7	1.07	1.11	Earthen Levee	Vegetation	WS Ma	M	V2 : Remove the wild growth other than native grasses from the levee slopes.	38.198602 ° -121.655605 °	38.199148 ° -121.655490 °	8 Y

Levee Mile Report Line	5
Start Levee Mile	1.03
End Levee Mile	1.03
Location	Water Side
Category	Supplemental
Item	USACE Erosion Survey

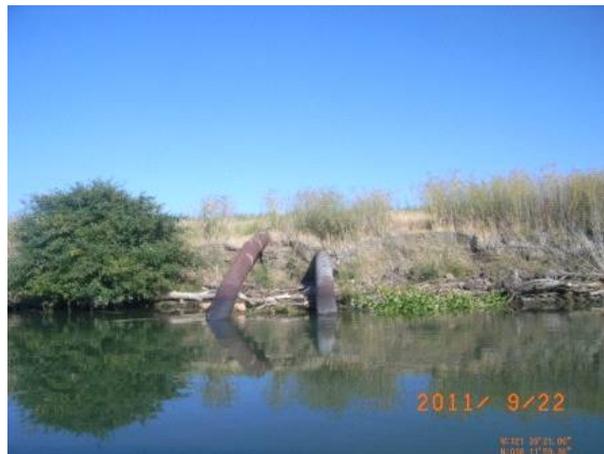
USACE 2011 Photo #2

Levee Mile Report Line	5
Start Levee Mile	1.03
End Levee Mile	1.03
Location	Water Side
Category	Supplemental
Item	USACE Erosion Survey

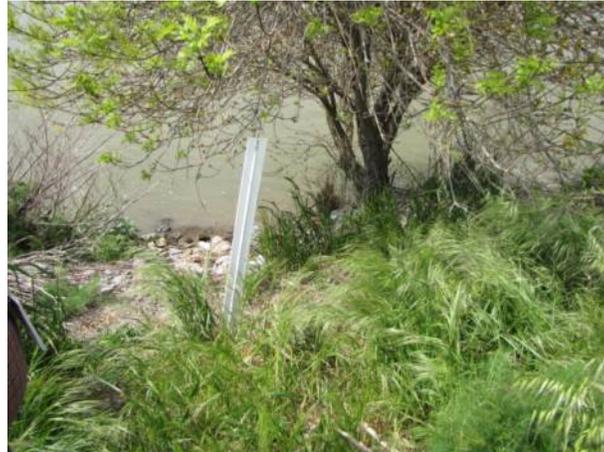
Levee Mile Report Line	6
Start Levee Mile	1.03
End Levee Mile	1.03
Location	Water Side
Category	Earthen Levee
Item	Erosion / Bank Caving
<p>Down at the base of the tree and the stake in view is bank erosion. This site was discovered 2-11 by a resident of the Hester property on the landside of the levee. The District has placed material in the eroded area however more is needed. Photo was taken 4-19-11.</p>	
<p>phillips_s_20120306_166.jpg</p>

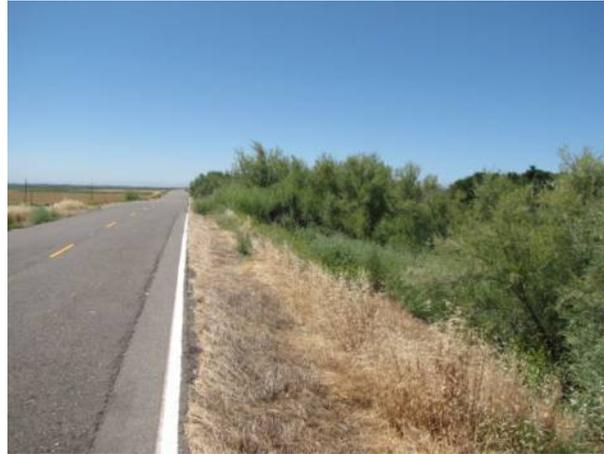
Levee Mile Report Line	12
Start Levee Mile	2.65
End Levee Mile	2.77
Location	Water Side
Category	Earthen Levee
Item	Trim / Thin Trees
Looking upstream from downstream end waterside.	
phillips_s_20120306_180.jpg

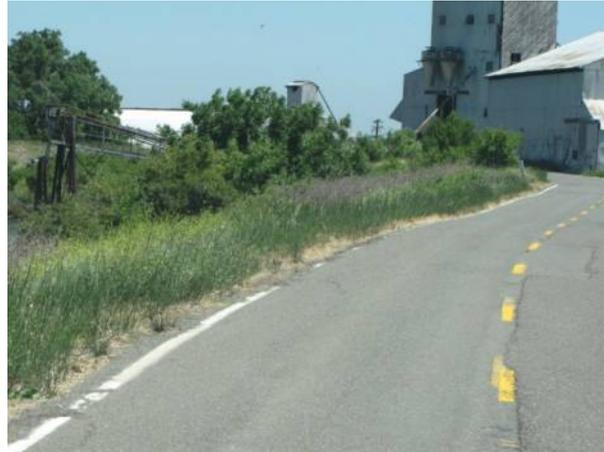
Levee Mile Report Line	14
Start Levee Mile	3.52
End Levee Mile	3.55
Location	Water Side
Category	Earthen Levee
Item	Trim / Thin Trees
Looking downstream from levee mile 3.52 wild growth has overtaken slope on waterside. Taken 11-03-2010	
phillips_s_20120306_182.jpg

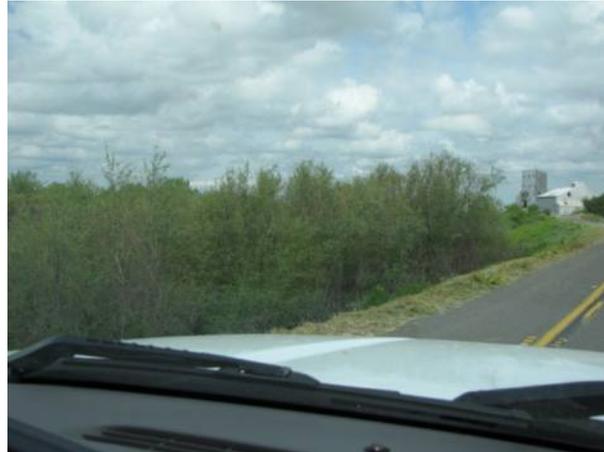
Levee Mile Report Line	14
Start Levee Mile	3.52
End Levee Mile	3.55
Location	Water Side
Category	Earthen Levee
Item	Trim / Thin Trees
New photo of waterside levee mile 3.52 to 3.55 looking downstream. Photo taken 4-19-11.	
phillips_s_20120306_185.jpg

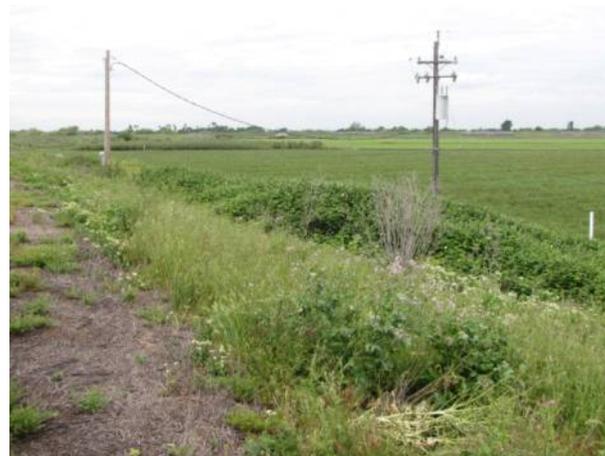
Levee Mile Report Line	20
Start Levee Mile	3.79
End Levee Mile	4.82
Location	Land Side
Category	Earthen Levee
Item	Vegetation

Looking downstream from landside unsatisfactory growth of wild berries on slope and toe. Photo taken 4-25-2012.

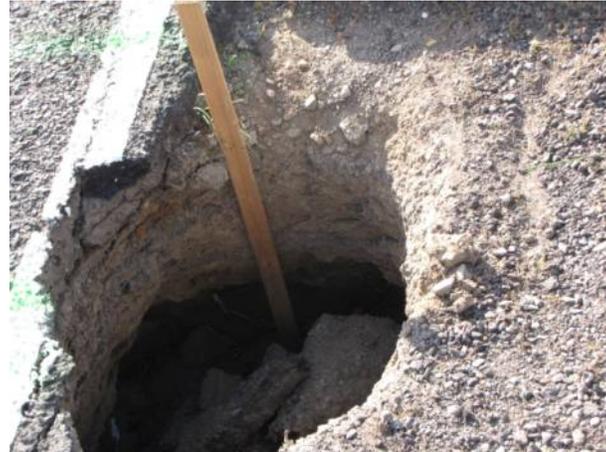
Another photo taken of the same. Photo taken 11-07-2011

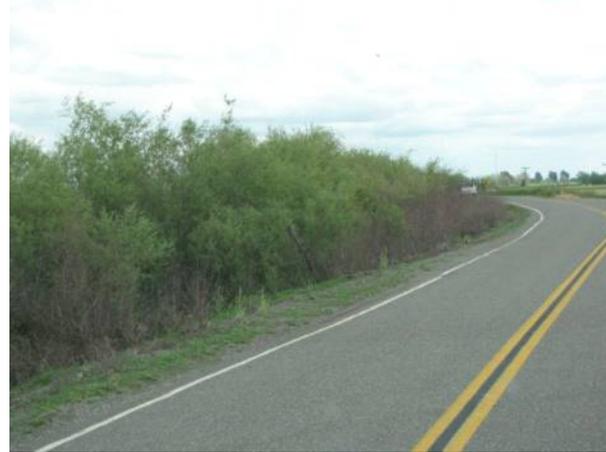
Levee Mile Report Line	26
Start Levee Mile	6.43
End Levee Mile	6.52
Location	Water Side
Category	Earthen Levee
Item	Trim / Thin Trees

New photo of waterside unsatisfactory growth levee mile 6.43 to 6.55 looking downstream. Photo taken 4-19-11.

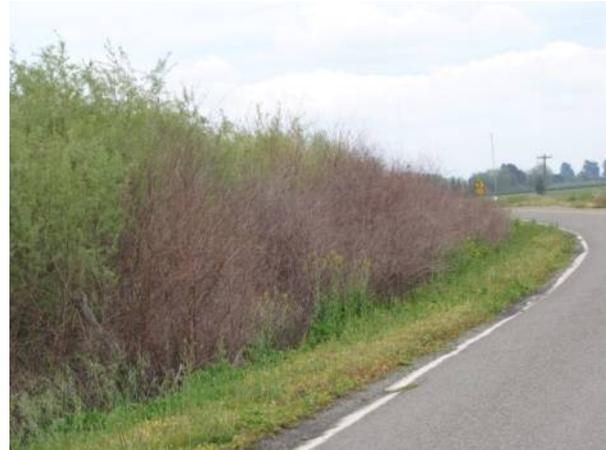
Levee Mile Report Line	26
Start Levee Mile	6.43
End Levee Mile	6.52
Location	Water Side
Category	Earthen Levee
Item	Trim / Thin Trees

Levee miles 6.43-6.52 waterside slope, can't see the levee section. Photo taken 4-25-2012.

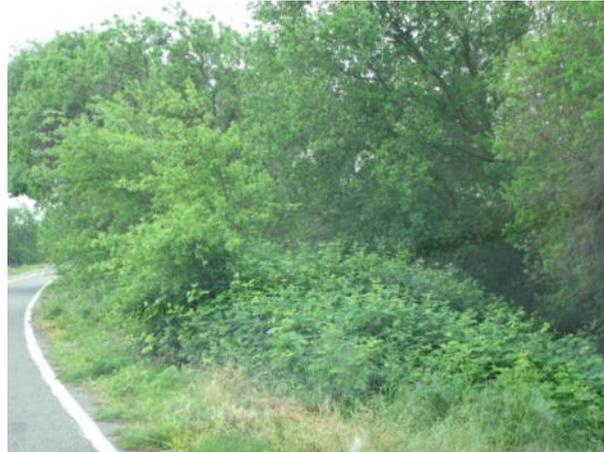
Levee Mile Report Line	13
Start Levee Mile	2.05
End Levee Mile	2.11
Location	Land Side
Category	Earthen Levee
Item	Vegetation
Levee mile 2.05-2.11 unsatisfactory wild growth taken over the landside levee section. Photo taken 4-25-2012.	
phillips_s_20120524_458.jpg
